HYGIENIC PULSATION DAMPERS AND SURGE ABSORBERS

Designed for CIP applications in the Pharmaceutical, Food, Confectionary,
Personal Care Products, Beverage and Brewing Industries

FLOWGUARD HYGIENIC PULSATION DAMPERS

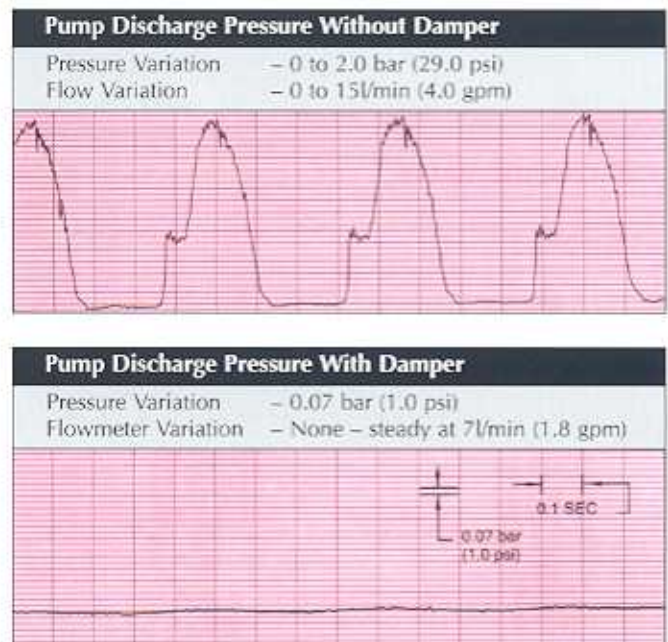
A plain vessel or standpipe could sometimes be used to achieve a similar effect. However, apart from the inherent difficulty of cleaning such a vessel under a CIP regime, the advantage of using a damping vessel with a flexible membrane is that the pre-charge gas is not absorbed by the process liquid and also the gas pressure can be set above atmospheric to keep size to a minimum. The two oscillograph traces shown here illustrate the pulsations caused by a 420 l/hr simplex metering pump both with and without a damper and show just how effective pulsation dampers can be.

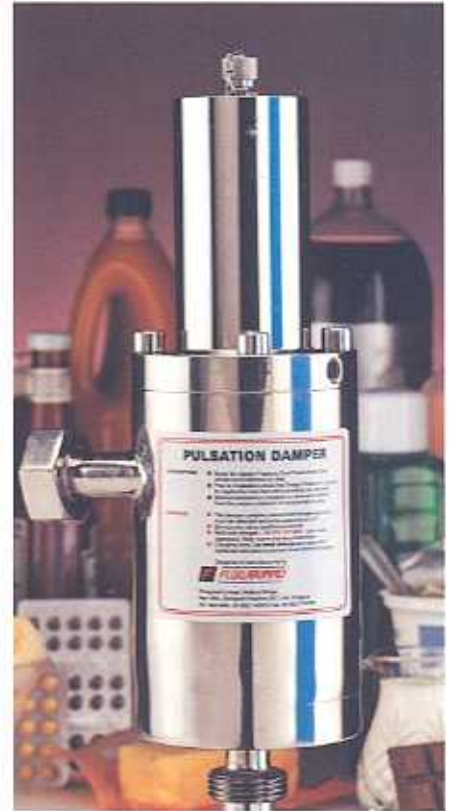
There can be a variety of physical results. Cracked pump casings, valves bodies, stems, seats and heat exchanger plates are not unknown and complete failure of the pipe itself can occur. Heat exchangers are particularly vulnerable. They can suffer from cross contamination due to the plate seals 'pumping' and the seals themselves can be damaged by pressure surges leading to the expensive process of re-sealing. Pressure surges can cause major problems such as damaged instrumentation, leaking joints, relief valves blowing off and blown bursting discs. Apart from the direct costs these incur, with some liquids there may be a cost impact from environmental considerations.

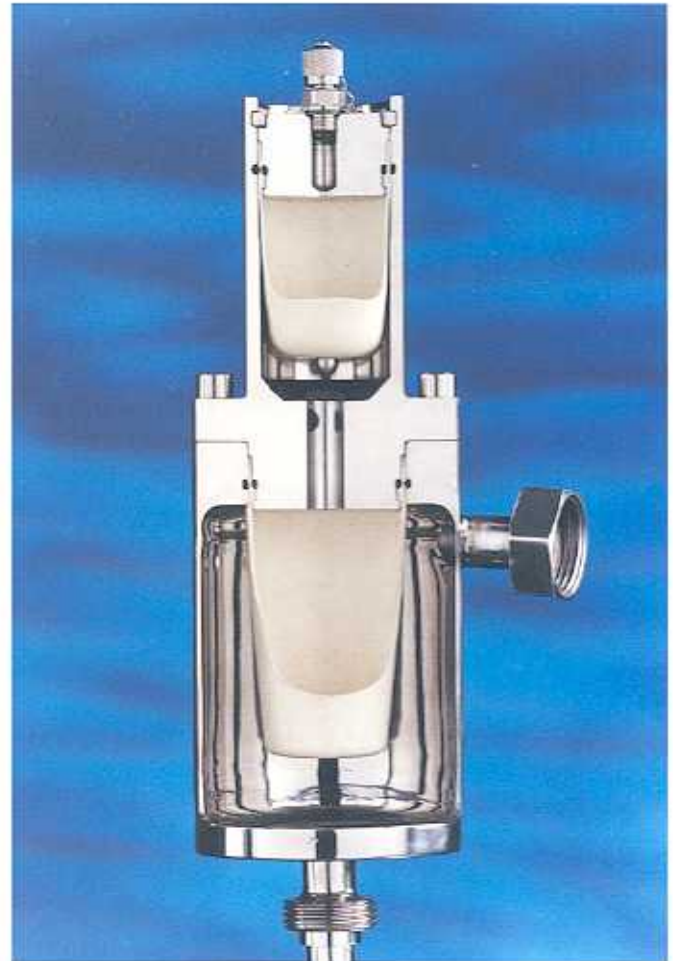
Connections

Process connection size is normally the same as the line diameter to avoid constriction of flow and maintain velocity. The connection type is specified to suit the customers requirements; any type can be provided such as RJT, IDF, ILC, SMS, DIN 11851, Tri-clamp etc.
